UNITED STATES ENVIRONMENTAL PROTECTION AGENCY
REGION III
1650 Arch Street
Philadelphia, Pennsylvania 19103-2029

Re: Request for Information Pursuant to Section 3007(a) of the Resource Conservation and Recovery Act, 42 U.S.C. § 6927(a), Regarding Generation and Management of Hazardous Waste by Akzo Nobel Coatings Inc.
EPA ID No. VAD000019828
Reference No. C06-003

Comprehensive Compliance Monitoring and Enforcement Report

AKZO Nobel
Roanoke, VA
VAD000019828

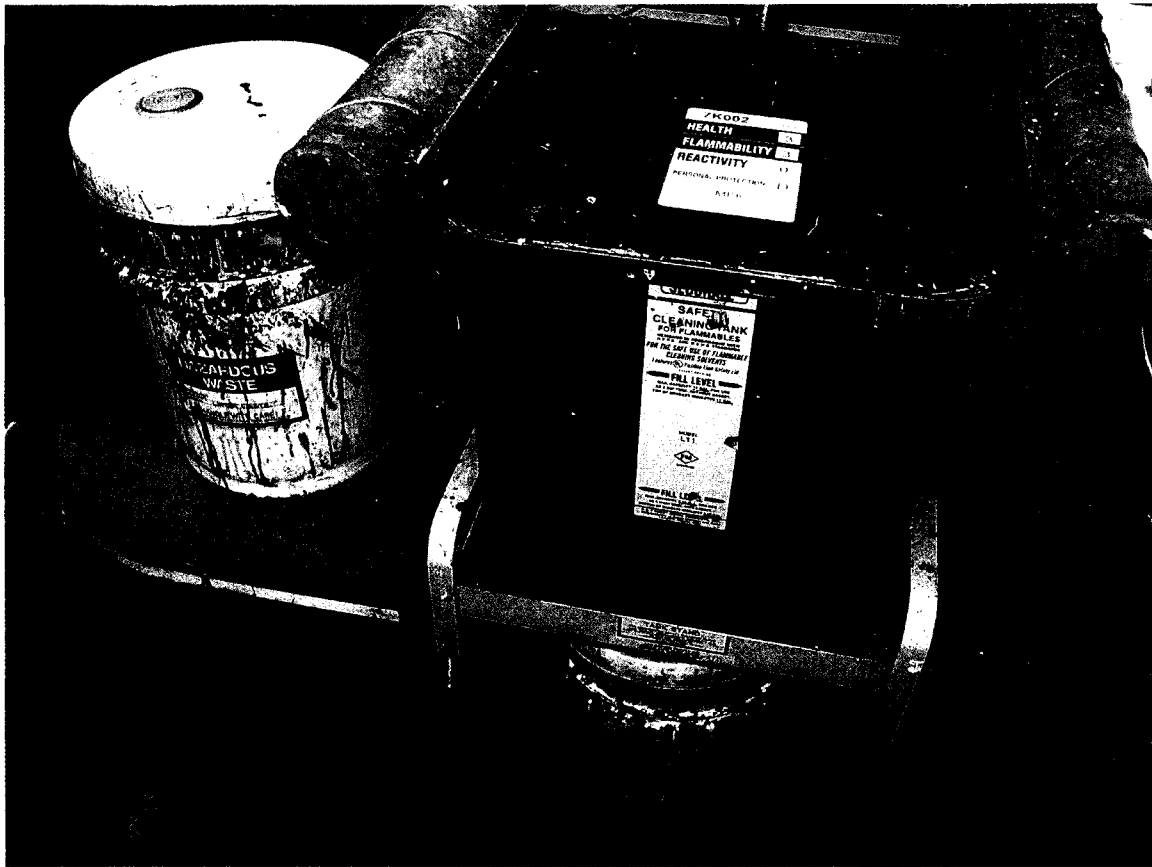
PHOTO 1

Satellite collection point in Water-based Lab
10 gal red flammable container holds solvent for cleaning
Top 5 gal HW container was about 80% full
5 gal container underneath is empty & for when 1st container gets full

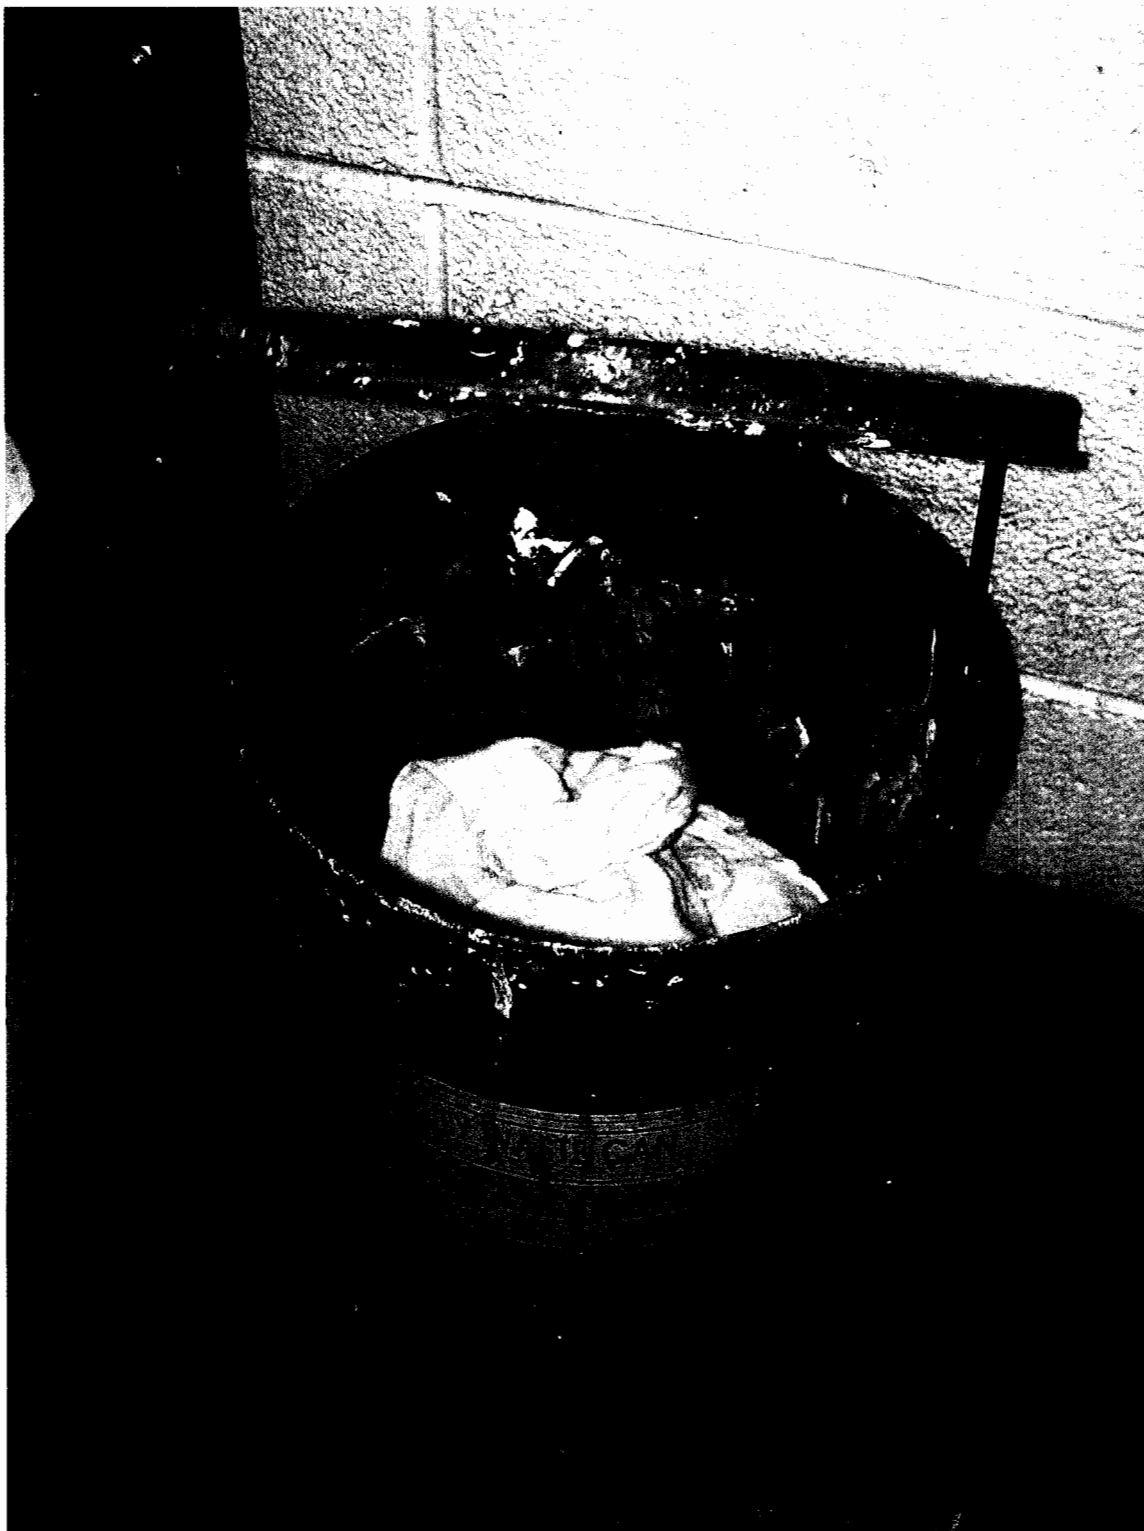
PHOTO 2

5 gal can of used rags, labeled "Oily Waste"

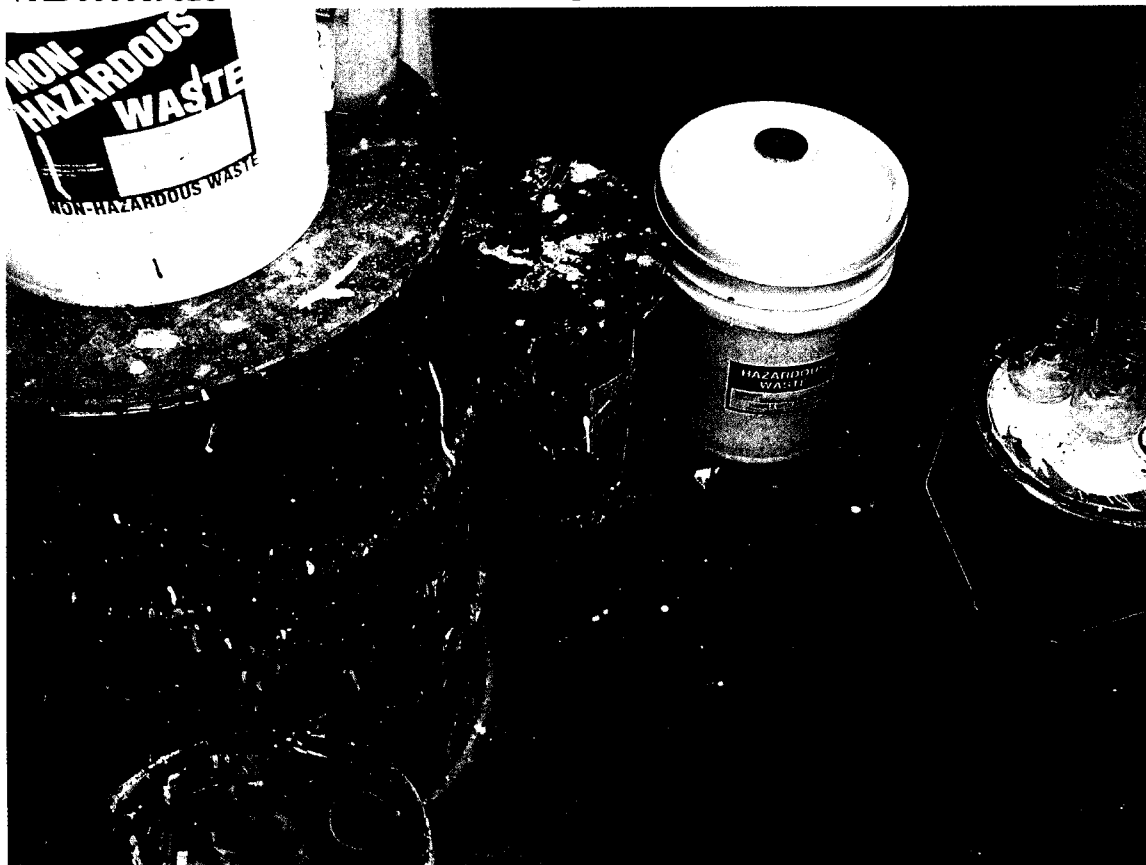
PHOTO 3

Water-based Lab (2nd room) Satellite collection point
5 gal HW container (white bucket on ground)
5 gal used rag container (red flammable can on ground)
5 gal container of Non-Hazardous Waste (white bucket on drum)

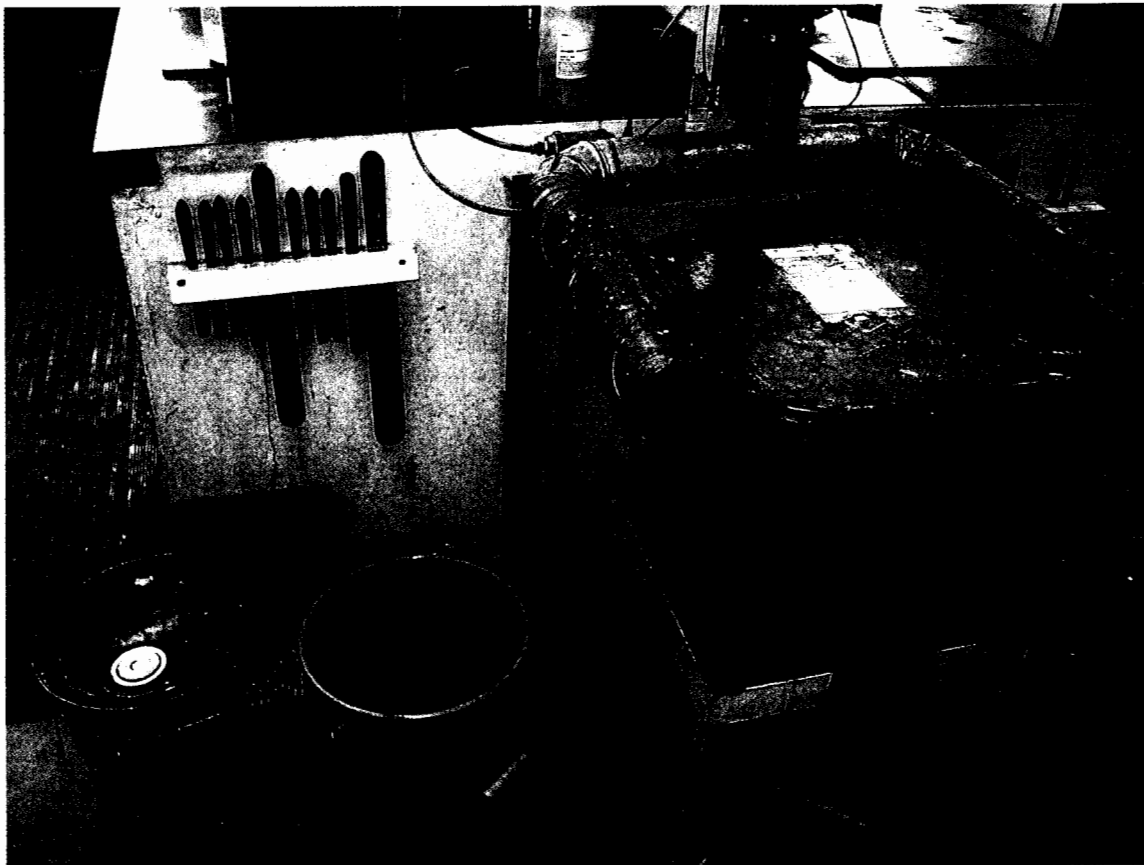
PHOTO 4

Lacquer Lab #2 Satellite collection point
5 gal gray container on left contained HW
Screen under lid did not allow for closure of container
Waste is used solvent from the covered container on stand

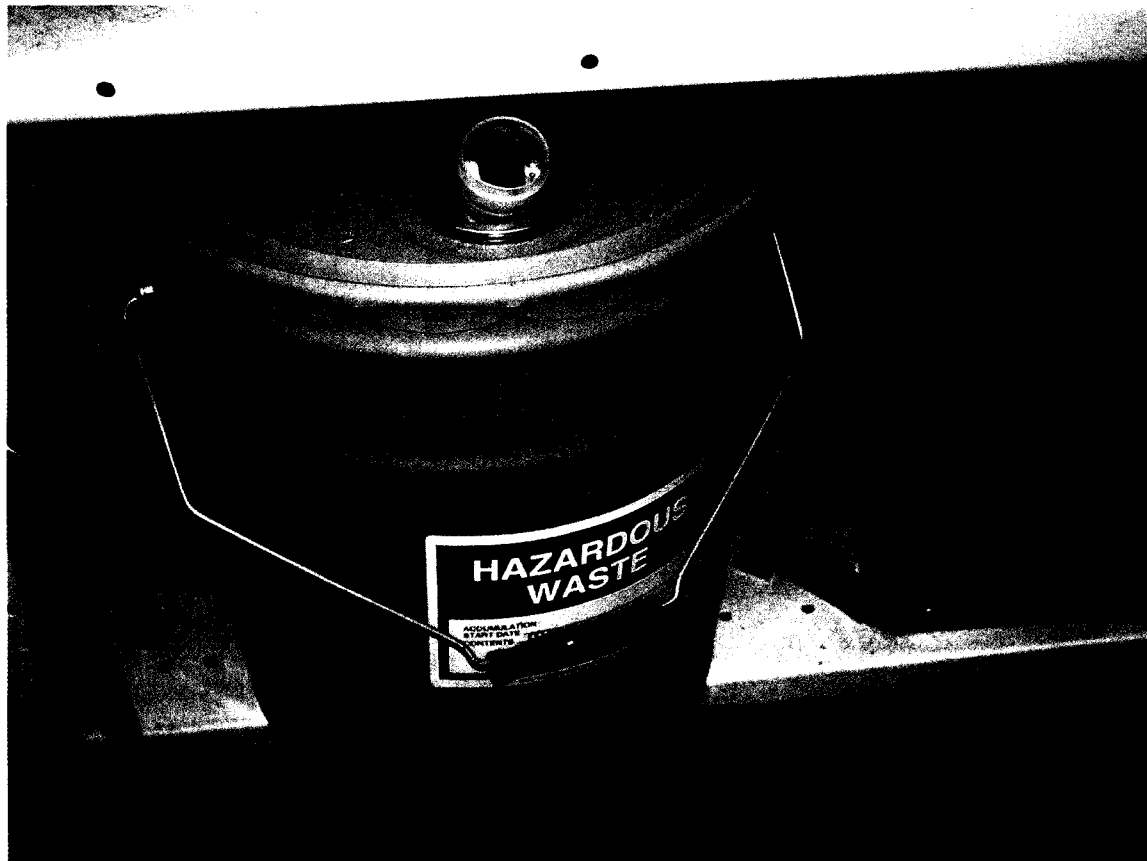
PHOTO 5

Physical Testing Room

5 gal container of "Mercury Waste" (broken thermometers from Labs)

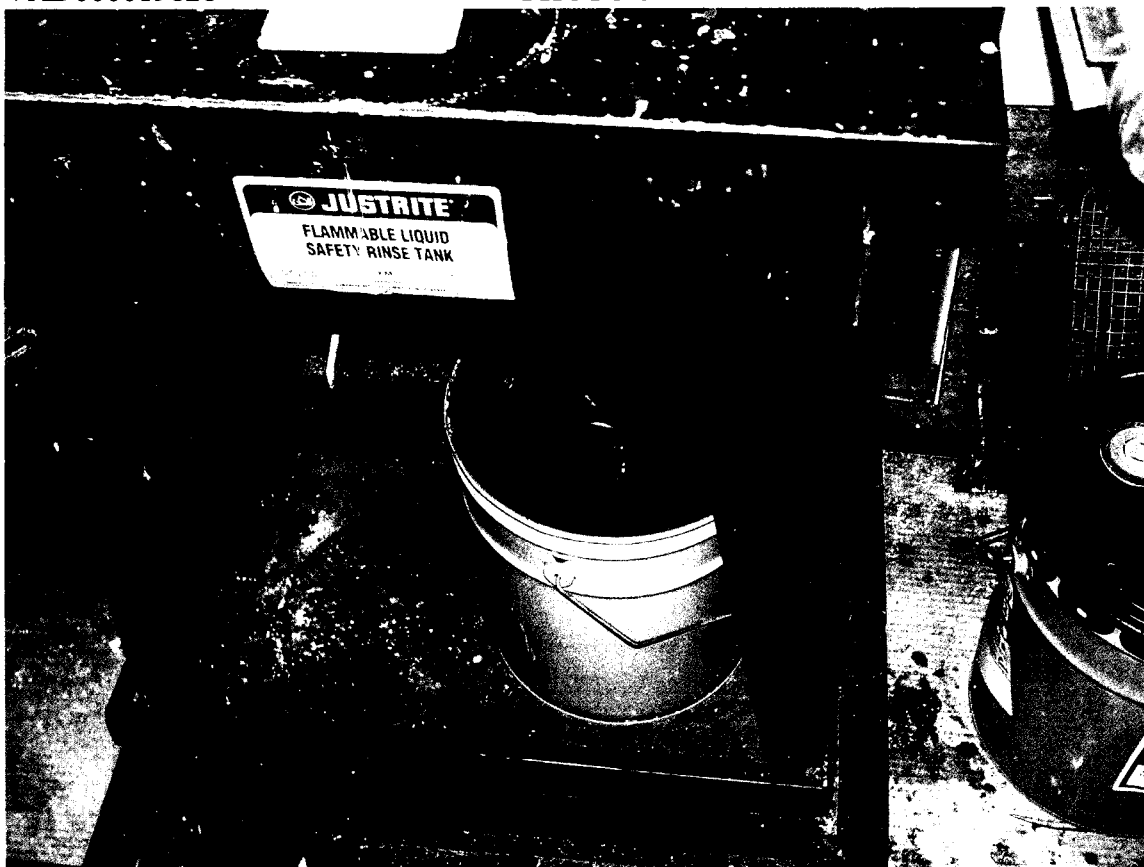
PHOTO 6

Lacquer Lab #1 Satellite collection point
5 gal container under rinse tank contained used solvent
Found open and unlabeled – facility personnel stated it was used MPK
Container was drained to a closed & labeled container during the inspection

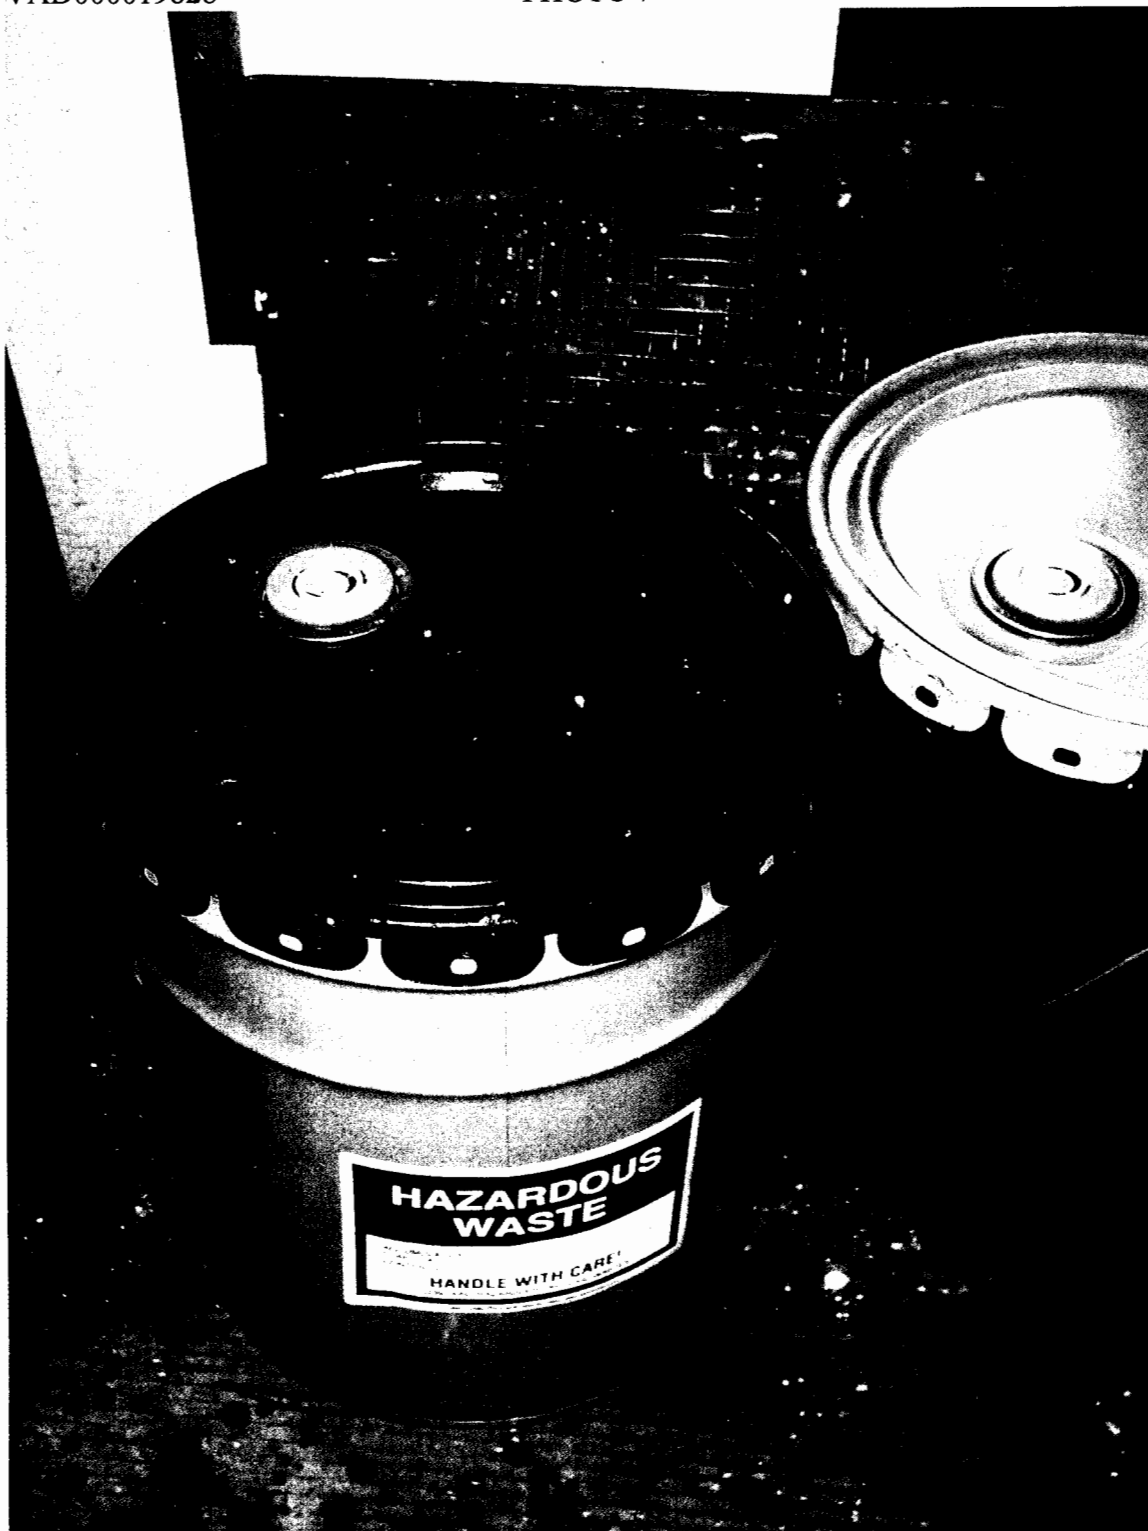
PHOTO 7

Screen removed from Photo 6 on ground

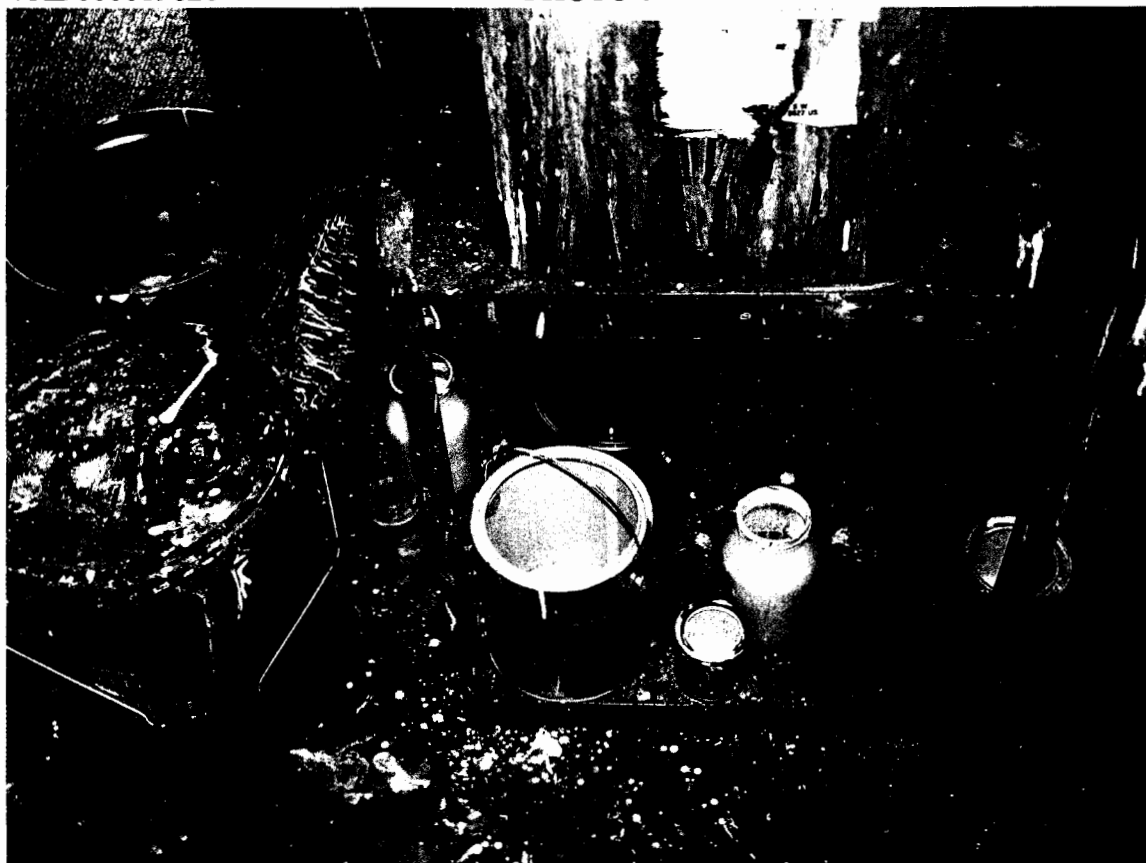
PHOTO 8

Paint Lab Satellite collection point
Several containers of paint left open to dry

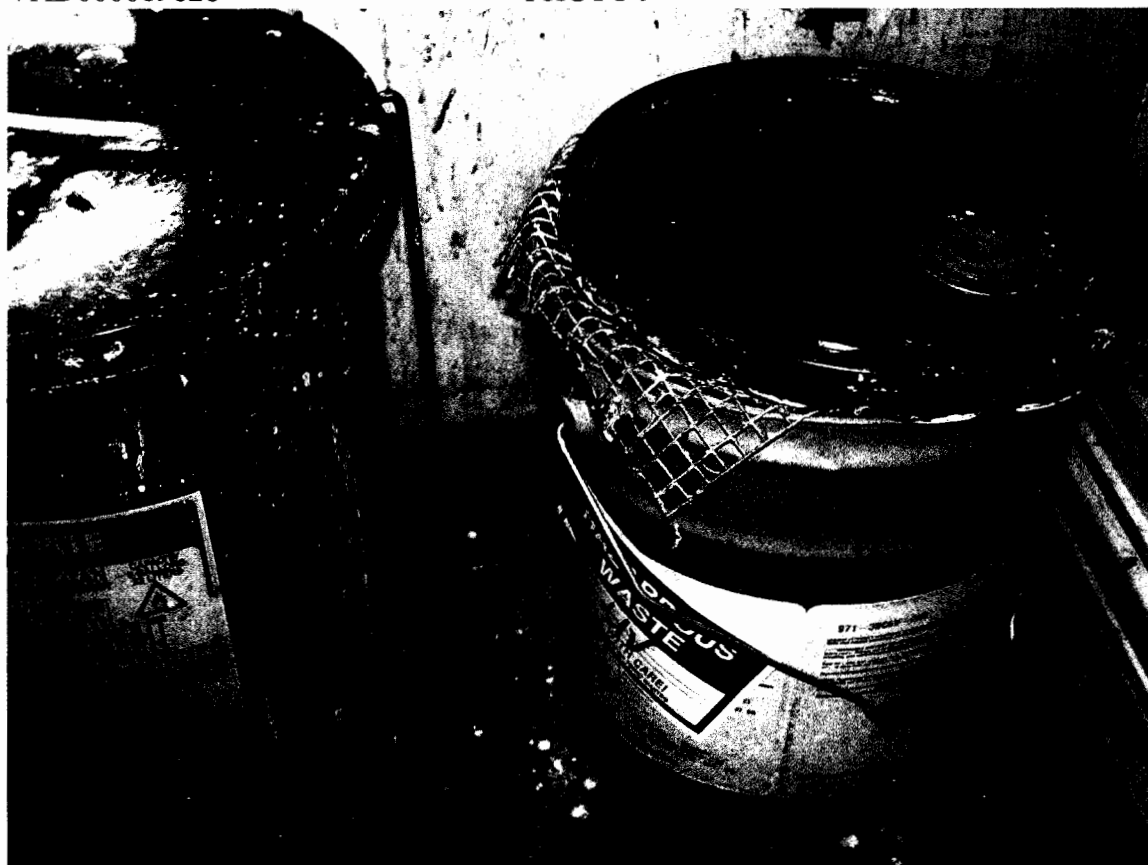
PHOTO 9

UV Lab

5 gal gray container holding HW is open with about 1 " of material inside
Staff stated the waste was mostly MEK with some UV materials

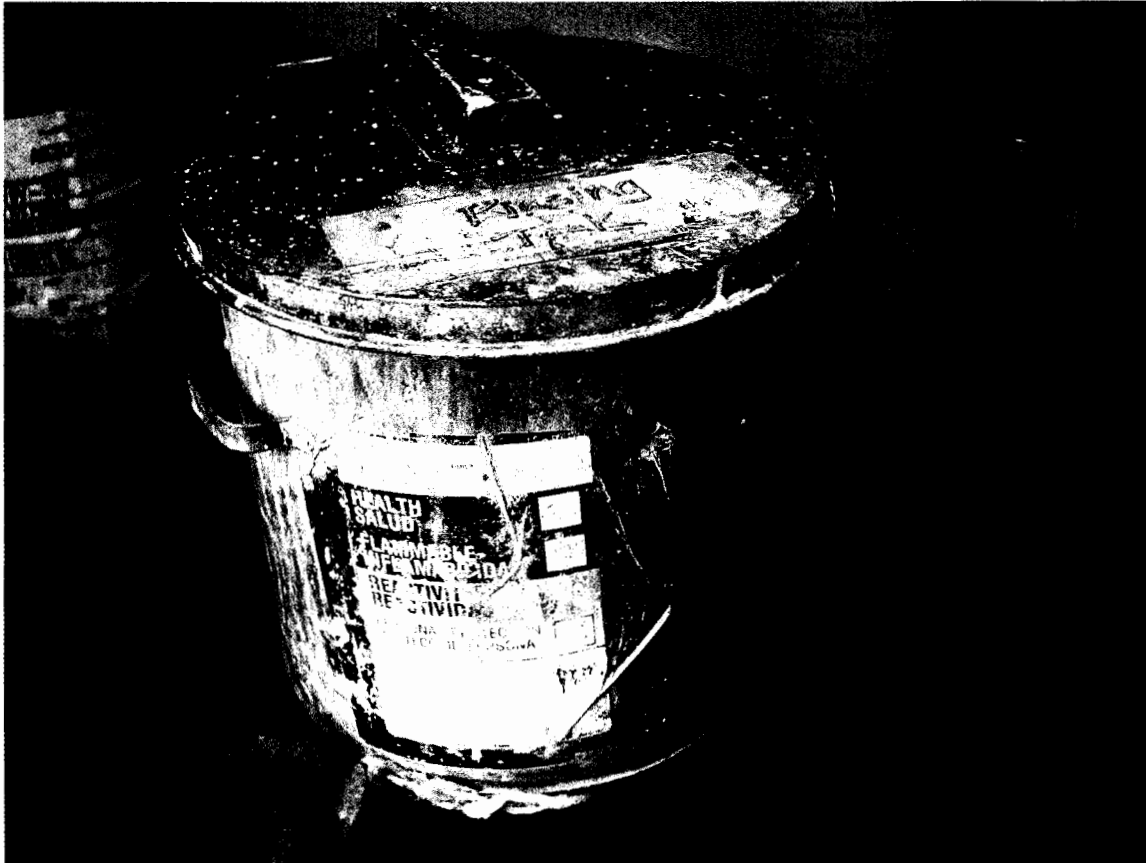
PHOTO 10

UV Lab – 3 gal container of cleaning solvent labeled “Rinsing Tank”

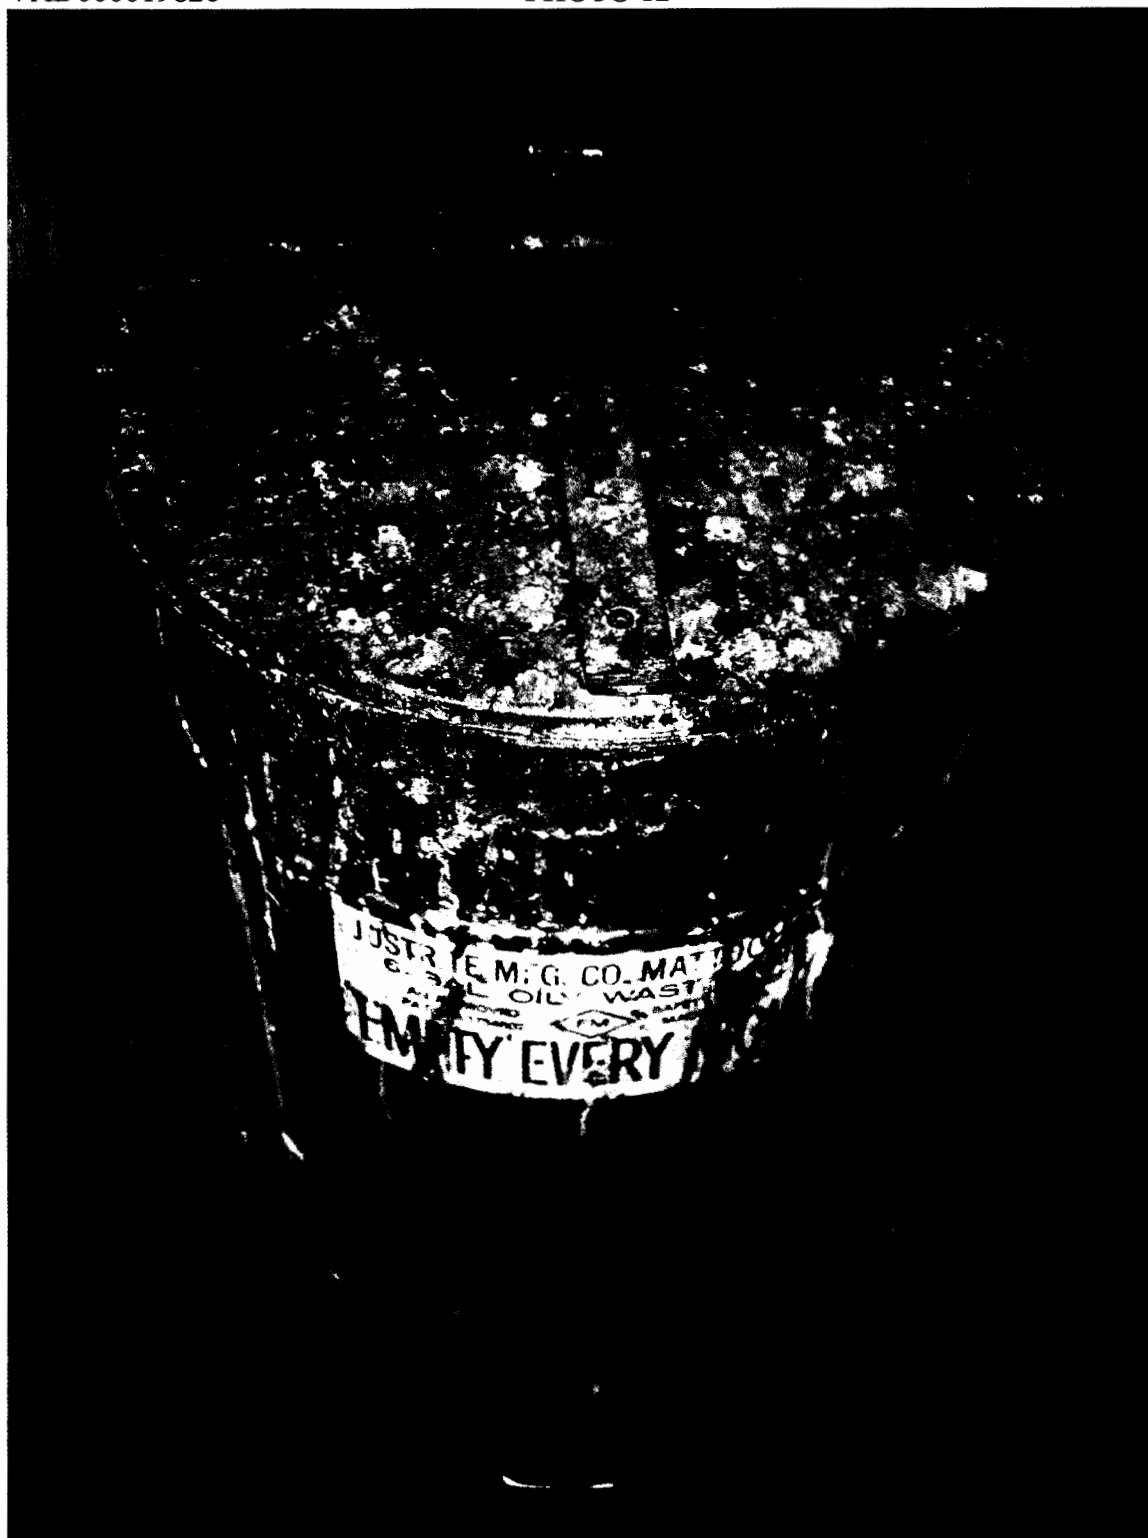
PHOTO 12

Large Workroom – container labeled only as “Oily Waste”
Some used rags inside

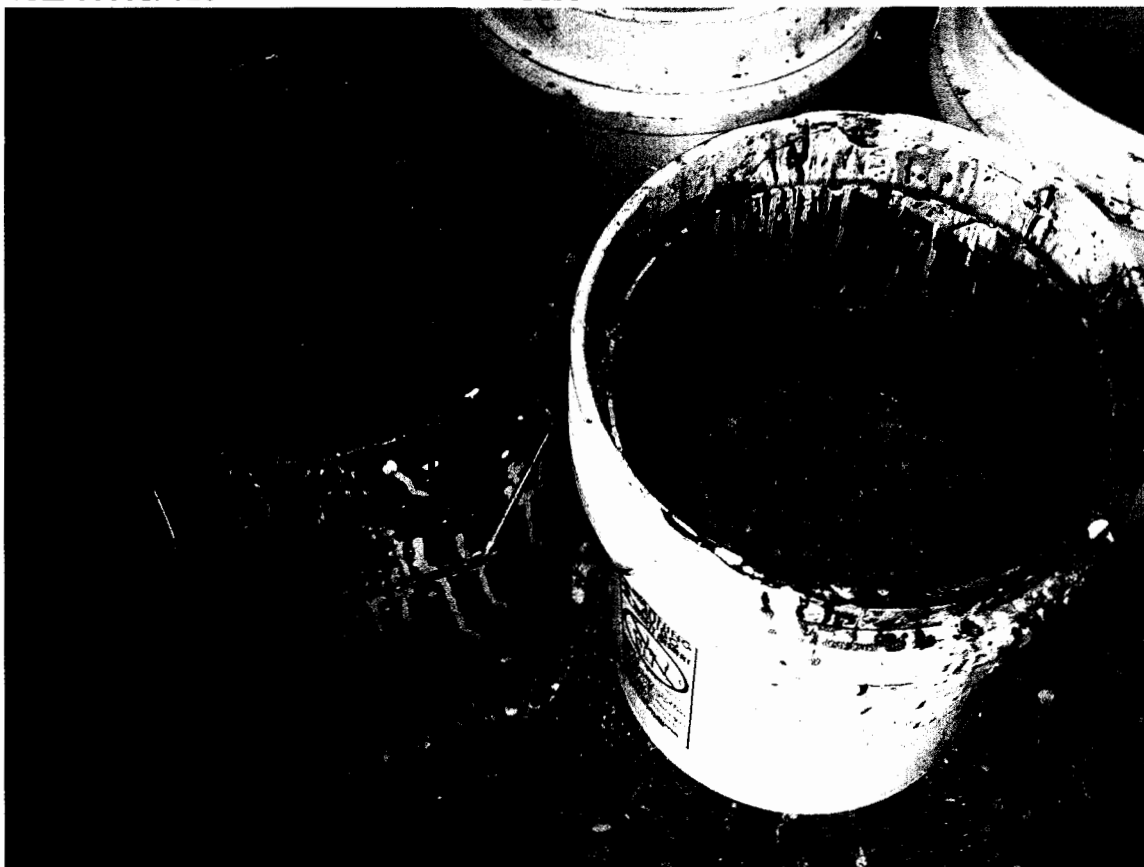
PHOTO 15

Less Than 90 Day Area – Storage Shed

Two open 5 gal containers, both about 1/3 full and unlabeled

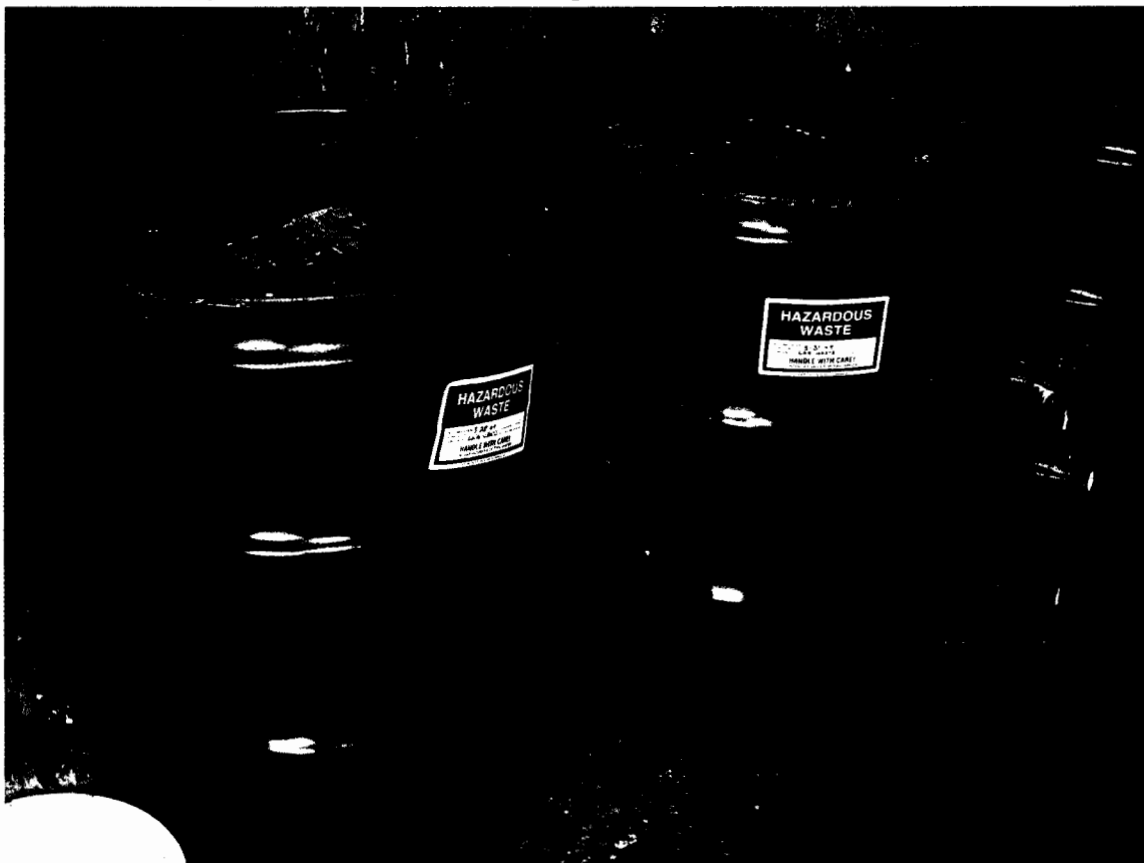
PHOTO 16

Less Than 90-Day Storage Area
Two 55 gal containers which are closed, labeled and dated

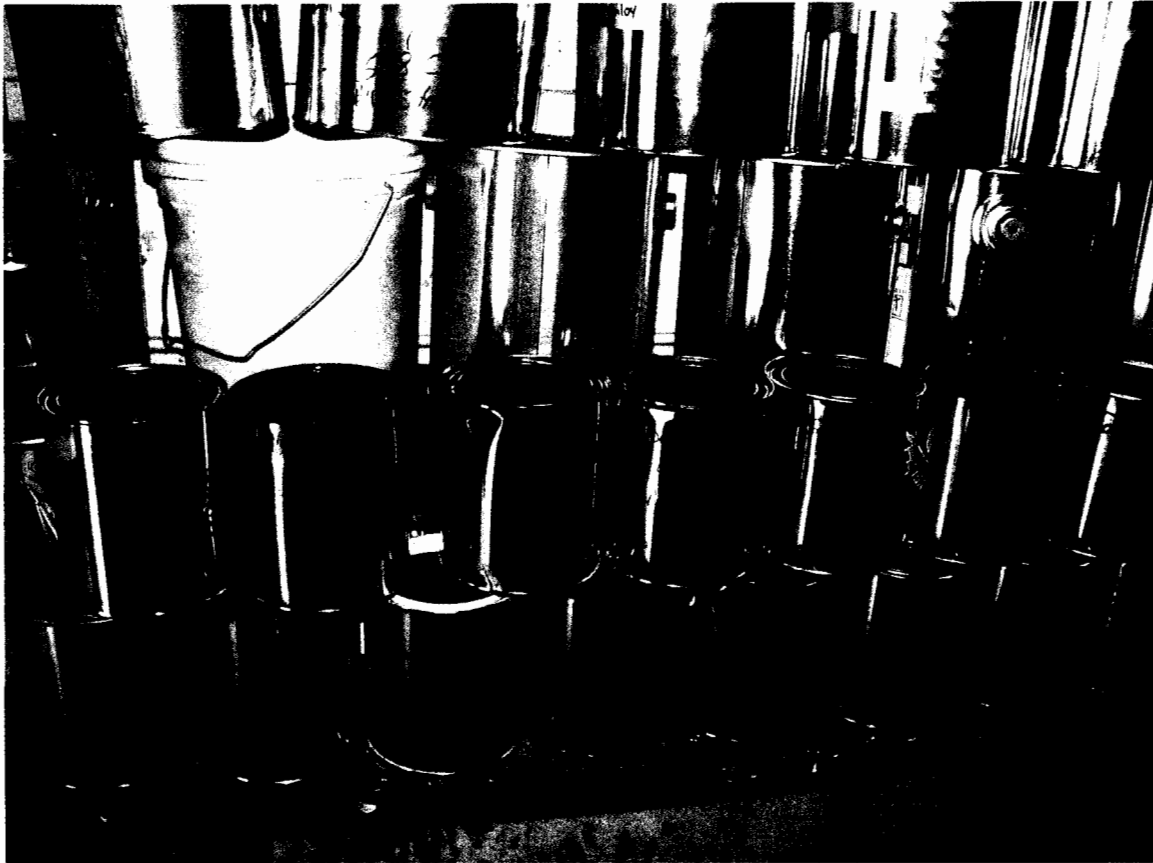
PHOTO 17

Less Than 90-Day Storage Area
Shelf with many open containers (samples & raw materials)
Containers are left to dry out before disposal as non-hazardous waste

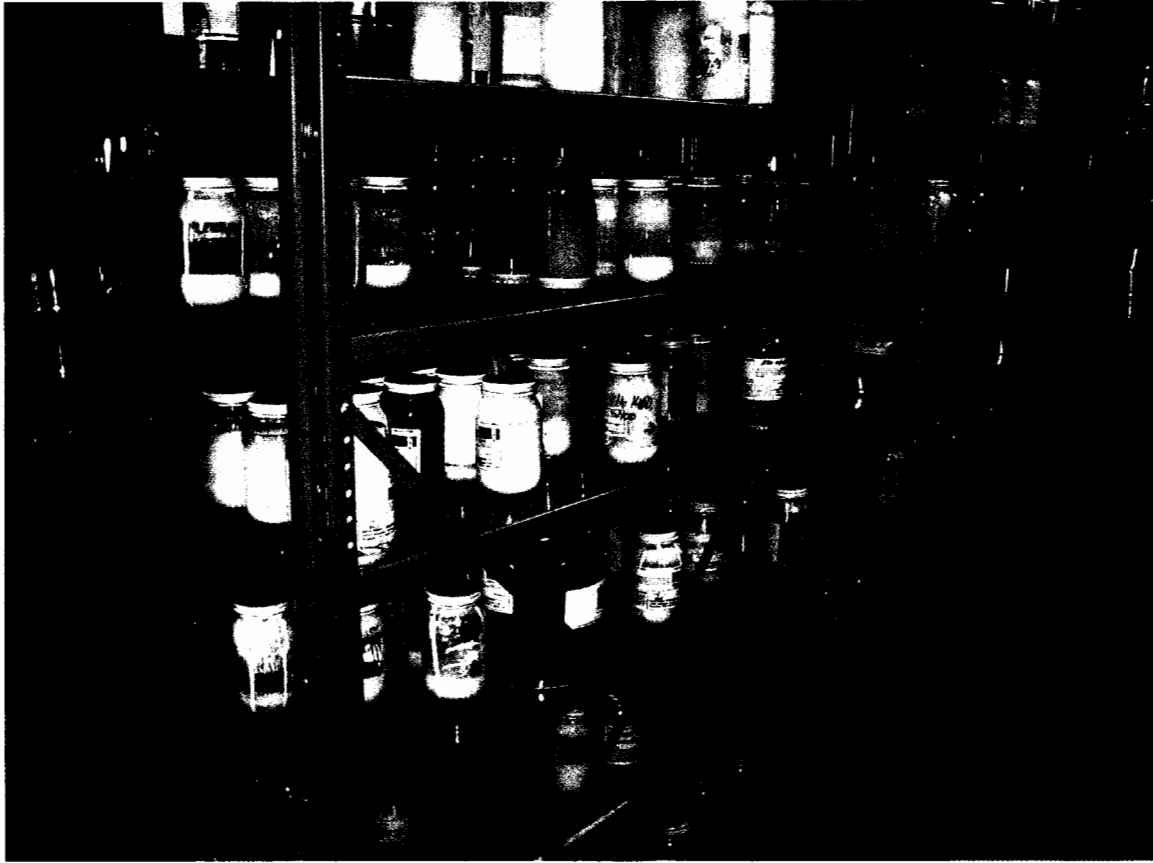
PHOTO 20

QC Standards Storage Room

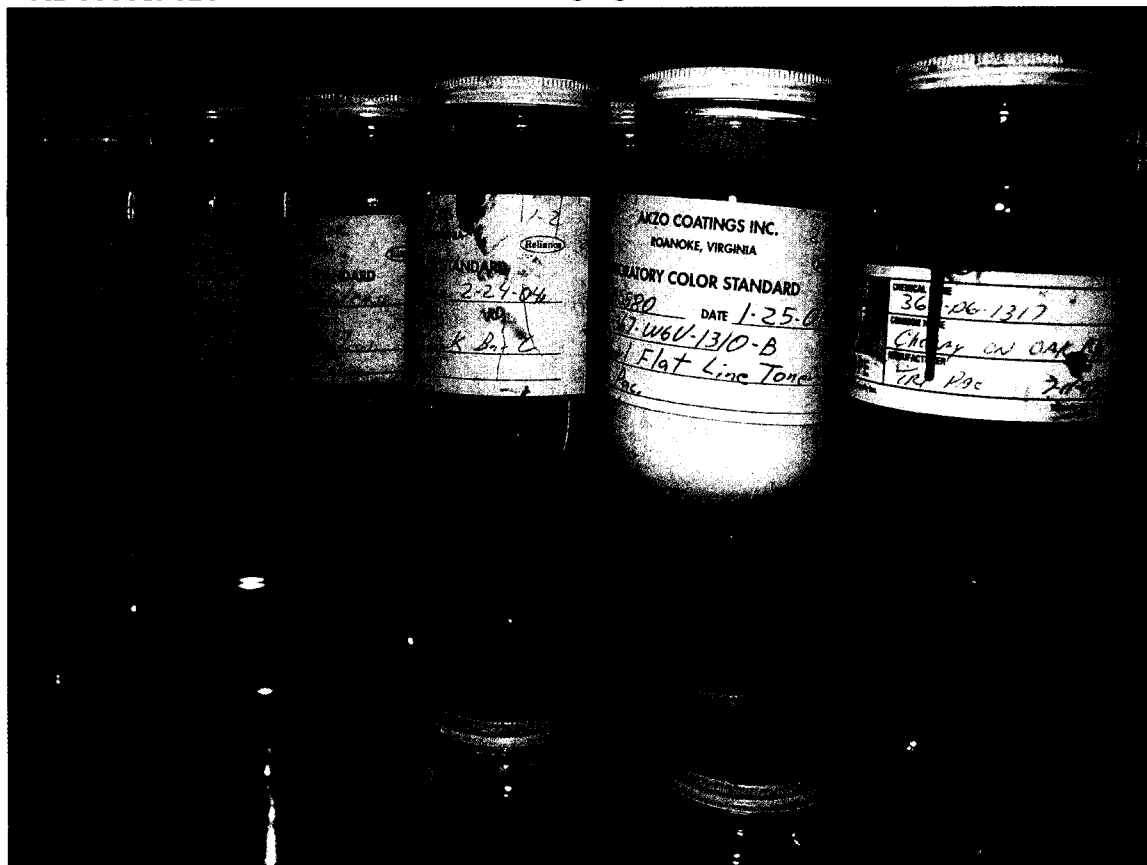
PHOTO 21

Standards – some dating back to 2000 & 2001

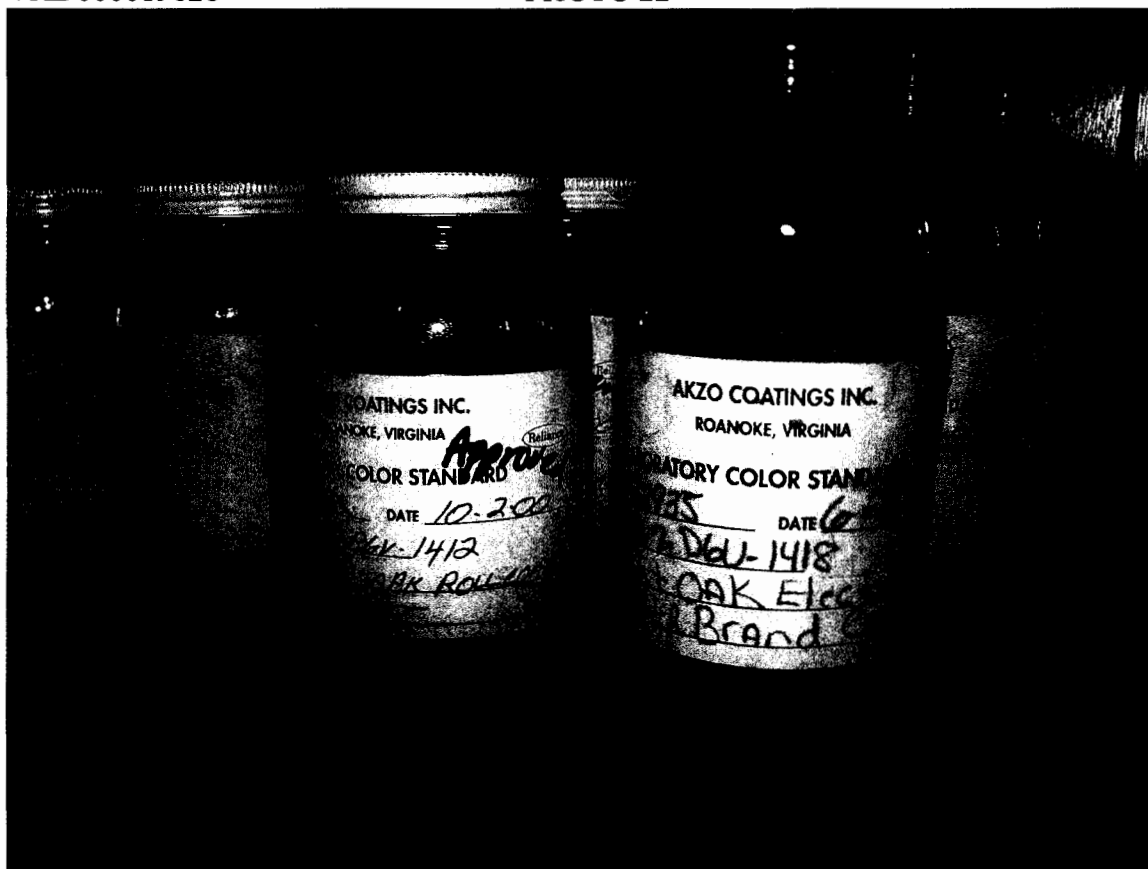
PHOTO 22

More standards dating back to 2000 & 2001

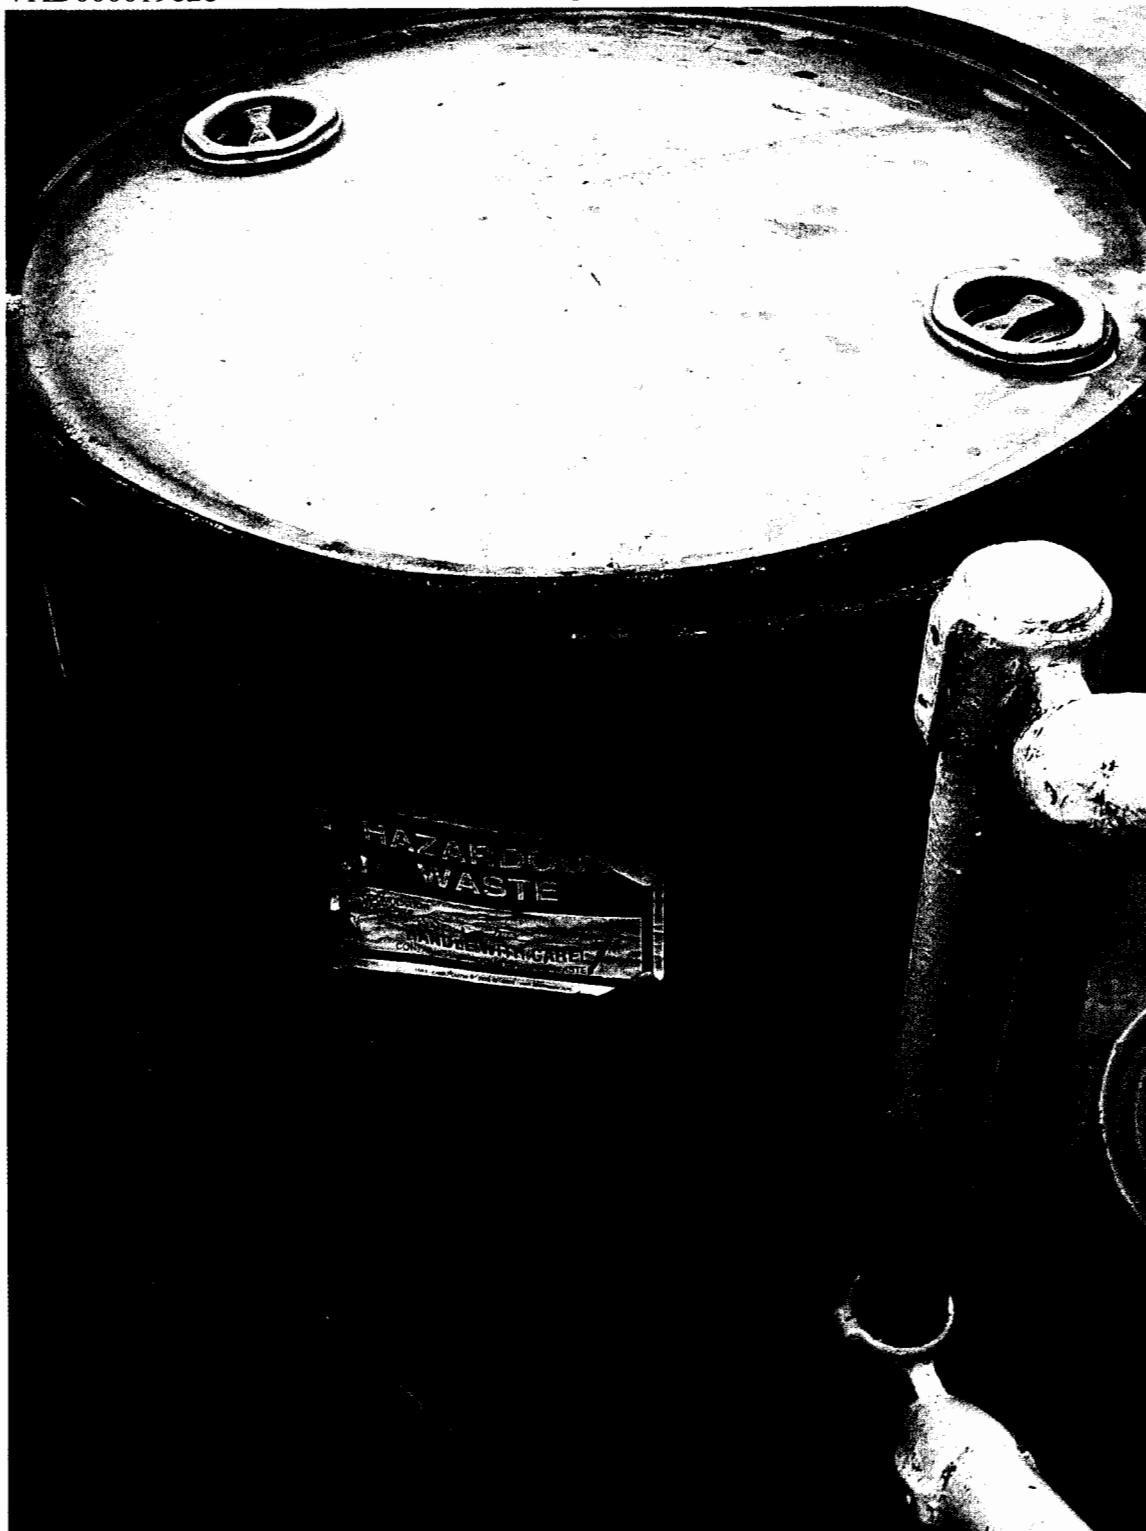
PHOTO 24

Alley outside of QC Lab door – Alley is between QC Lab & Manufacturing Buildings
55 gal container labeled “Hazardous Waste” and “QC Lab”
Drum was approx. $\frac{1}{4}$ full and unlabeled

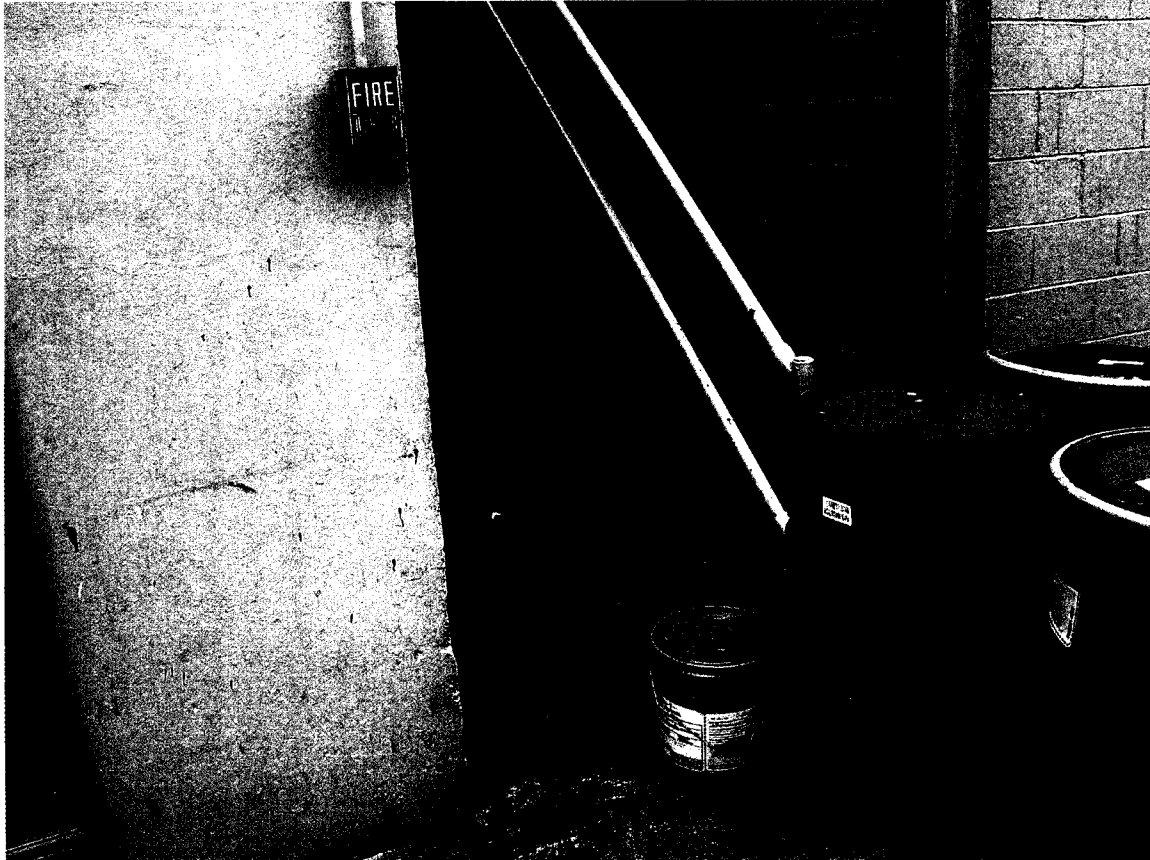
The facility representative stated that HW is removed from the building on a daily basis to a satellite container in the Main Manufacturing building. Just outside the QC Lab that opens onto the alley between the Lab and the Main Mfg building a container was found. (PHOTO 24) This container was labeled as Hazardous Waste and was also marked as "QC Lab". The container was found to be about 25% full with material

exhibiting a strong solvent odor. The container was undated and found to be out-of-round such that the cover did not effectively close the container. The facility representative could not explain this container's existence. PHOTO 25 shows the location of this container. Door to the Lab is just outside of the picture to the left.

Location of drum from PHOTO 24
QC Lab Building is on the left

9. While inspecting the Quality Control Laboratory area, the inspector observed a steel container just outside of the Quality Control Lab. The container was labeled as hazardous waste and marked as "QC LAB". An accumulation start date was not observed on this container. (see Photographs 24 & 25) With regard to this container:
